Report Number NCAP-TRC-98-005

New Car Assessment Program (NCAP)

Flat Frontal Barrier Impact Test

1998 Volvo S-70

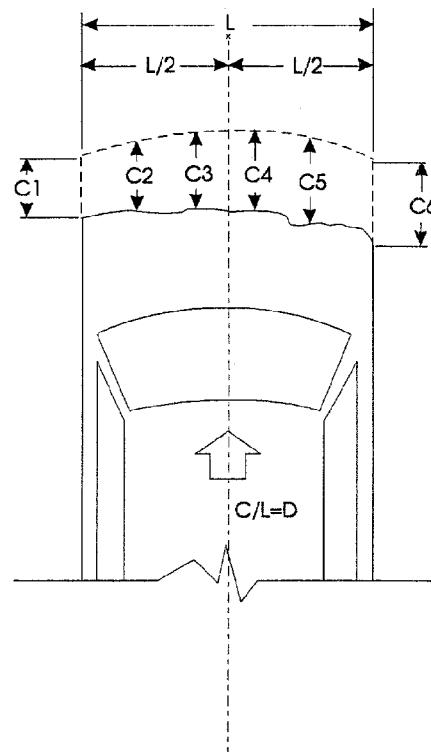
Collision Deformation  
Classification (CDC) code: 12FDEW3

Crush depth measurements:	C1 = 491 mm
	C2 = 547 mm
	C3 = 584 mm
	C4 = 575 mm
	C5 = 560 mm
	C6 = 472 mm

Midpoint of damage: D: Vehicle Longitudinal Centerline

Length of damaged region: L: 1524 mm

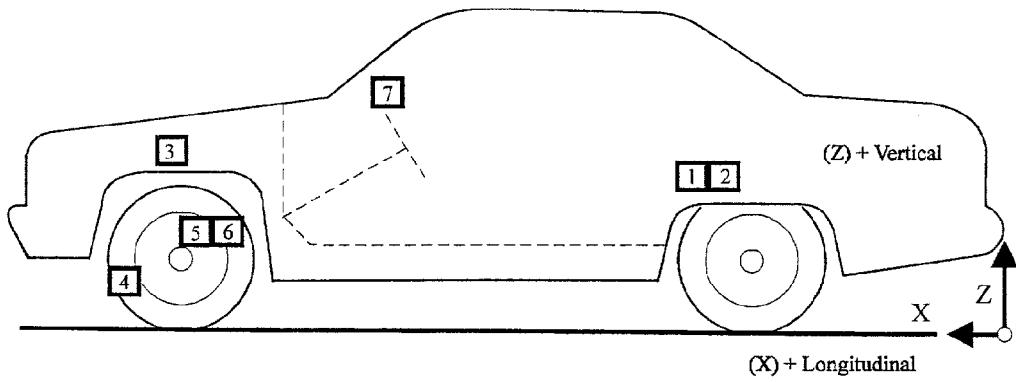
Figure 3 Vehicle Accelerometer Placement

Side View

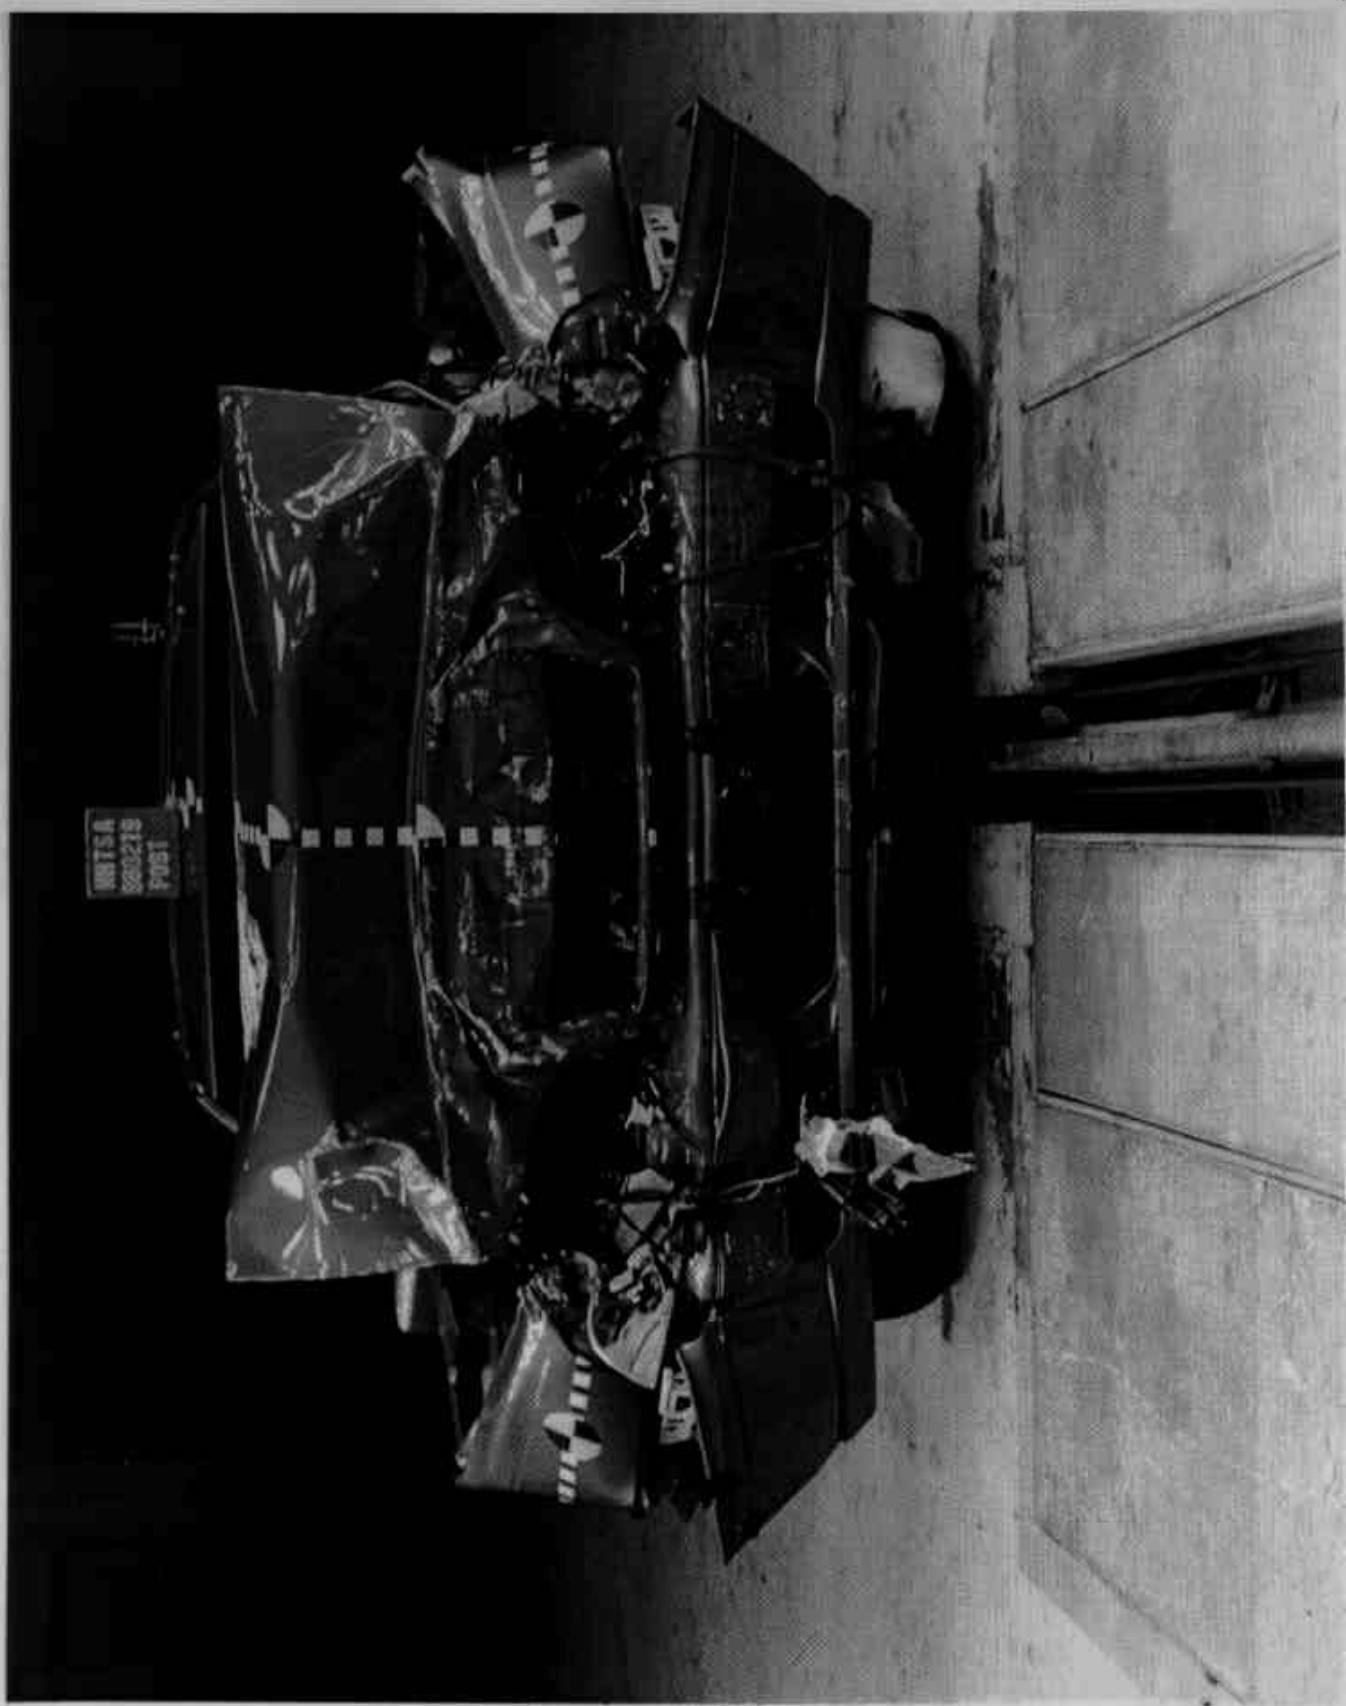
Figure A-2 Post-Test Front View

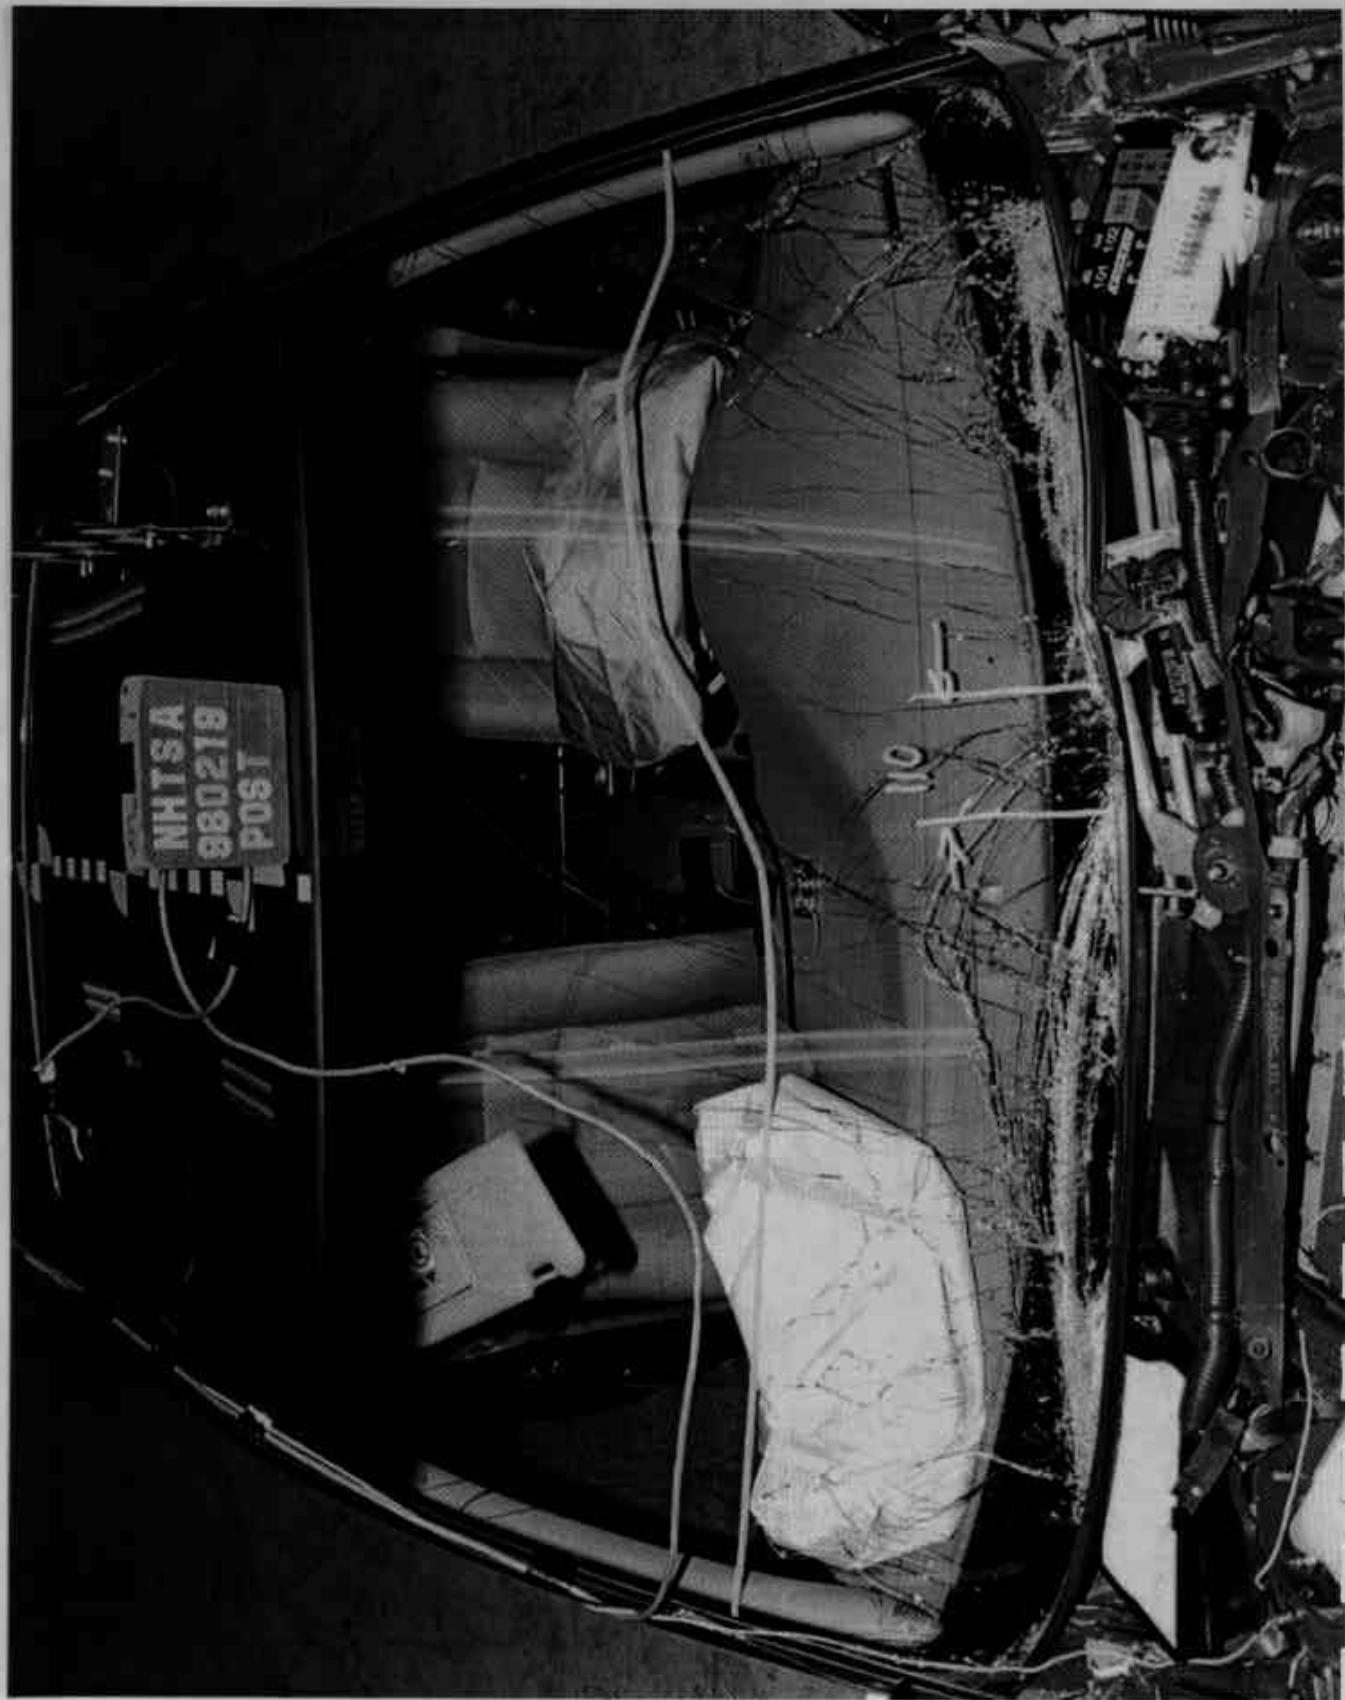
Figure A-14 Post-Test Windshield View

Glazing Damage: The lower portion of the windshield was cracked on impact.

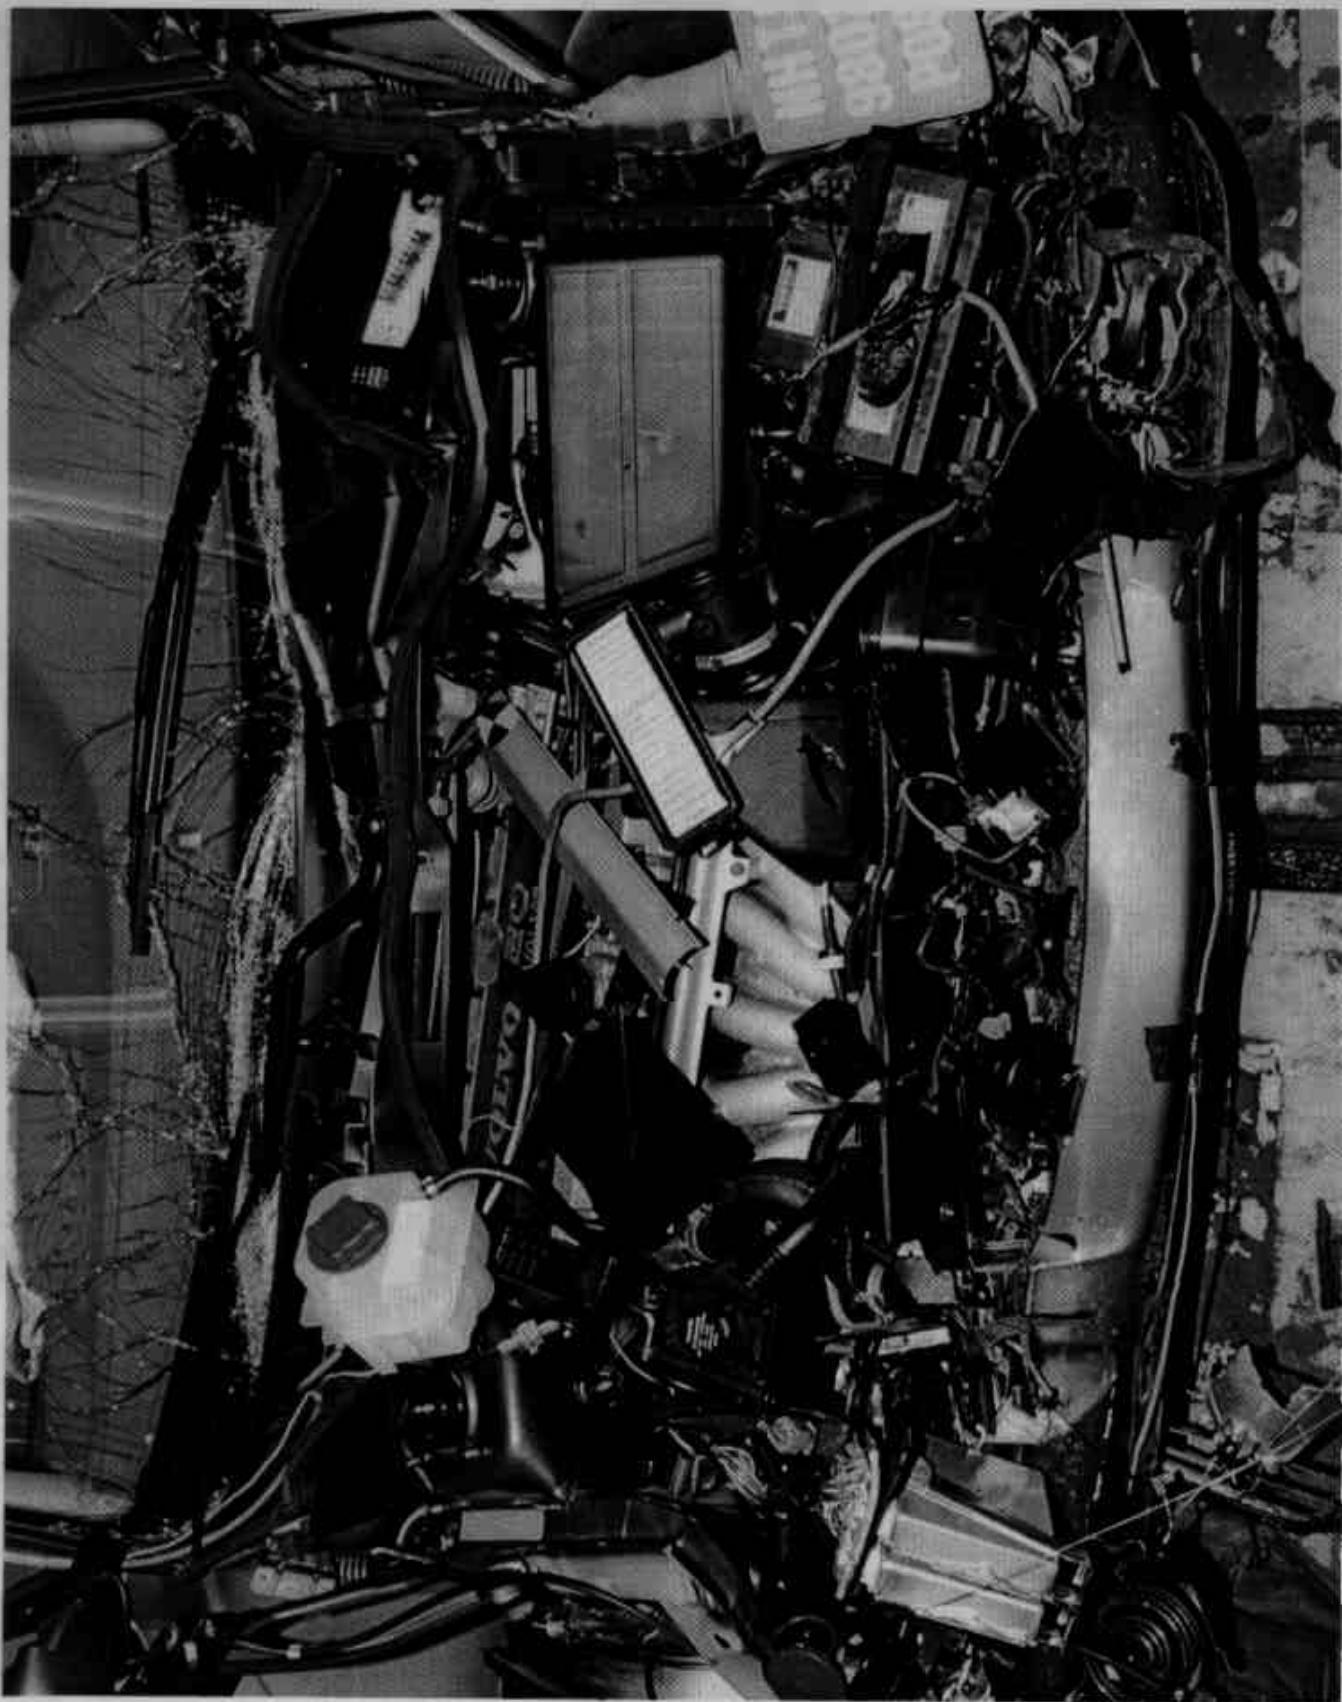
Figure A-16 Post-Test Engine Compartment View

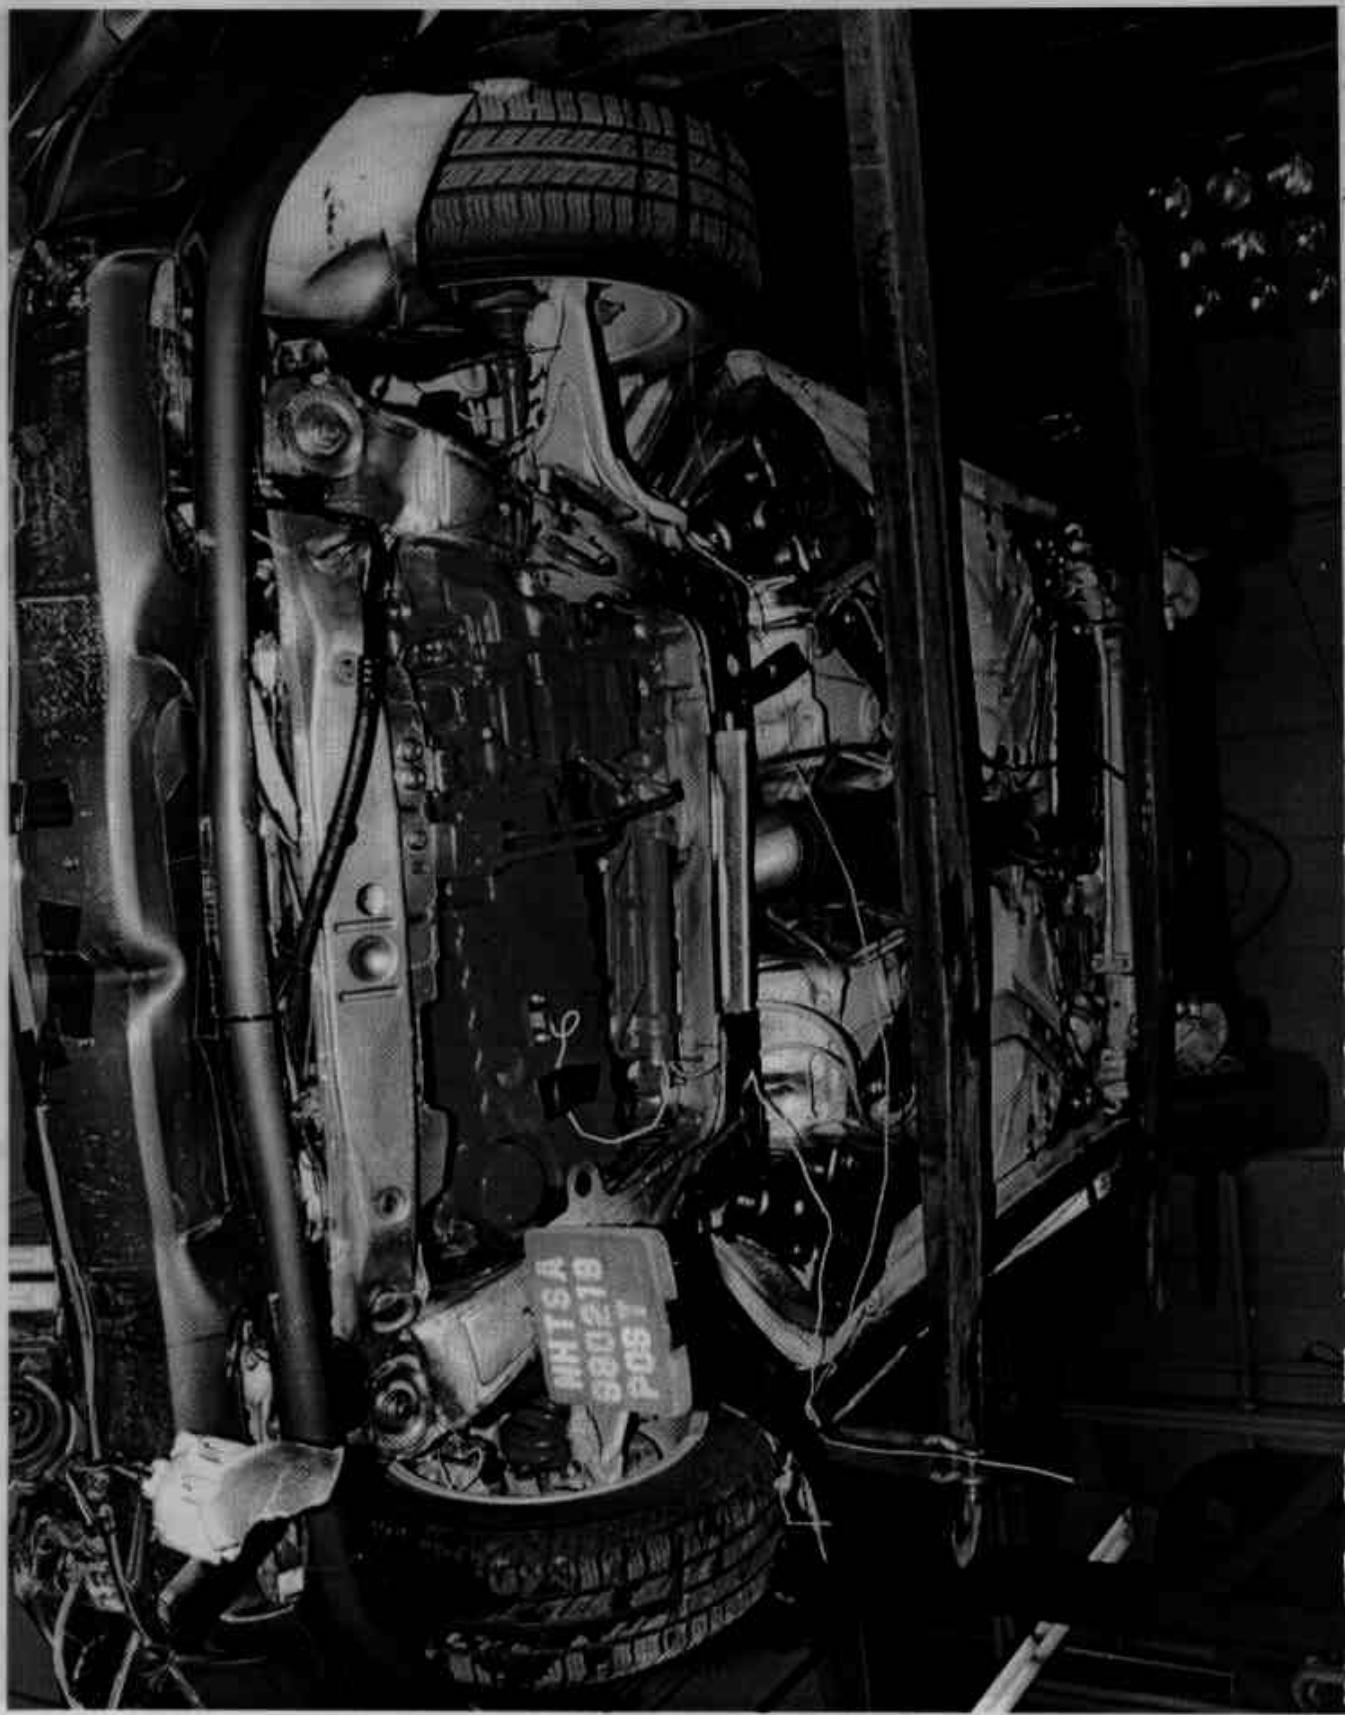
Figure A-24 Post-Test Front Underbody View

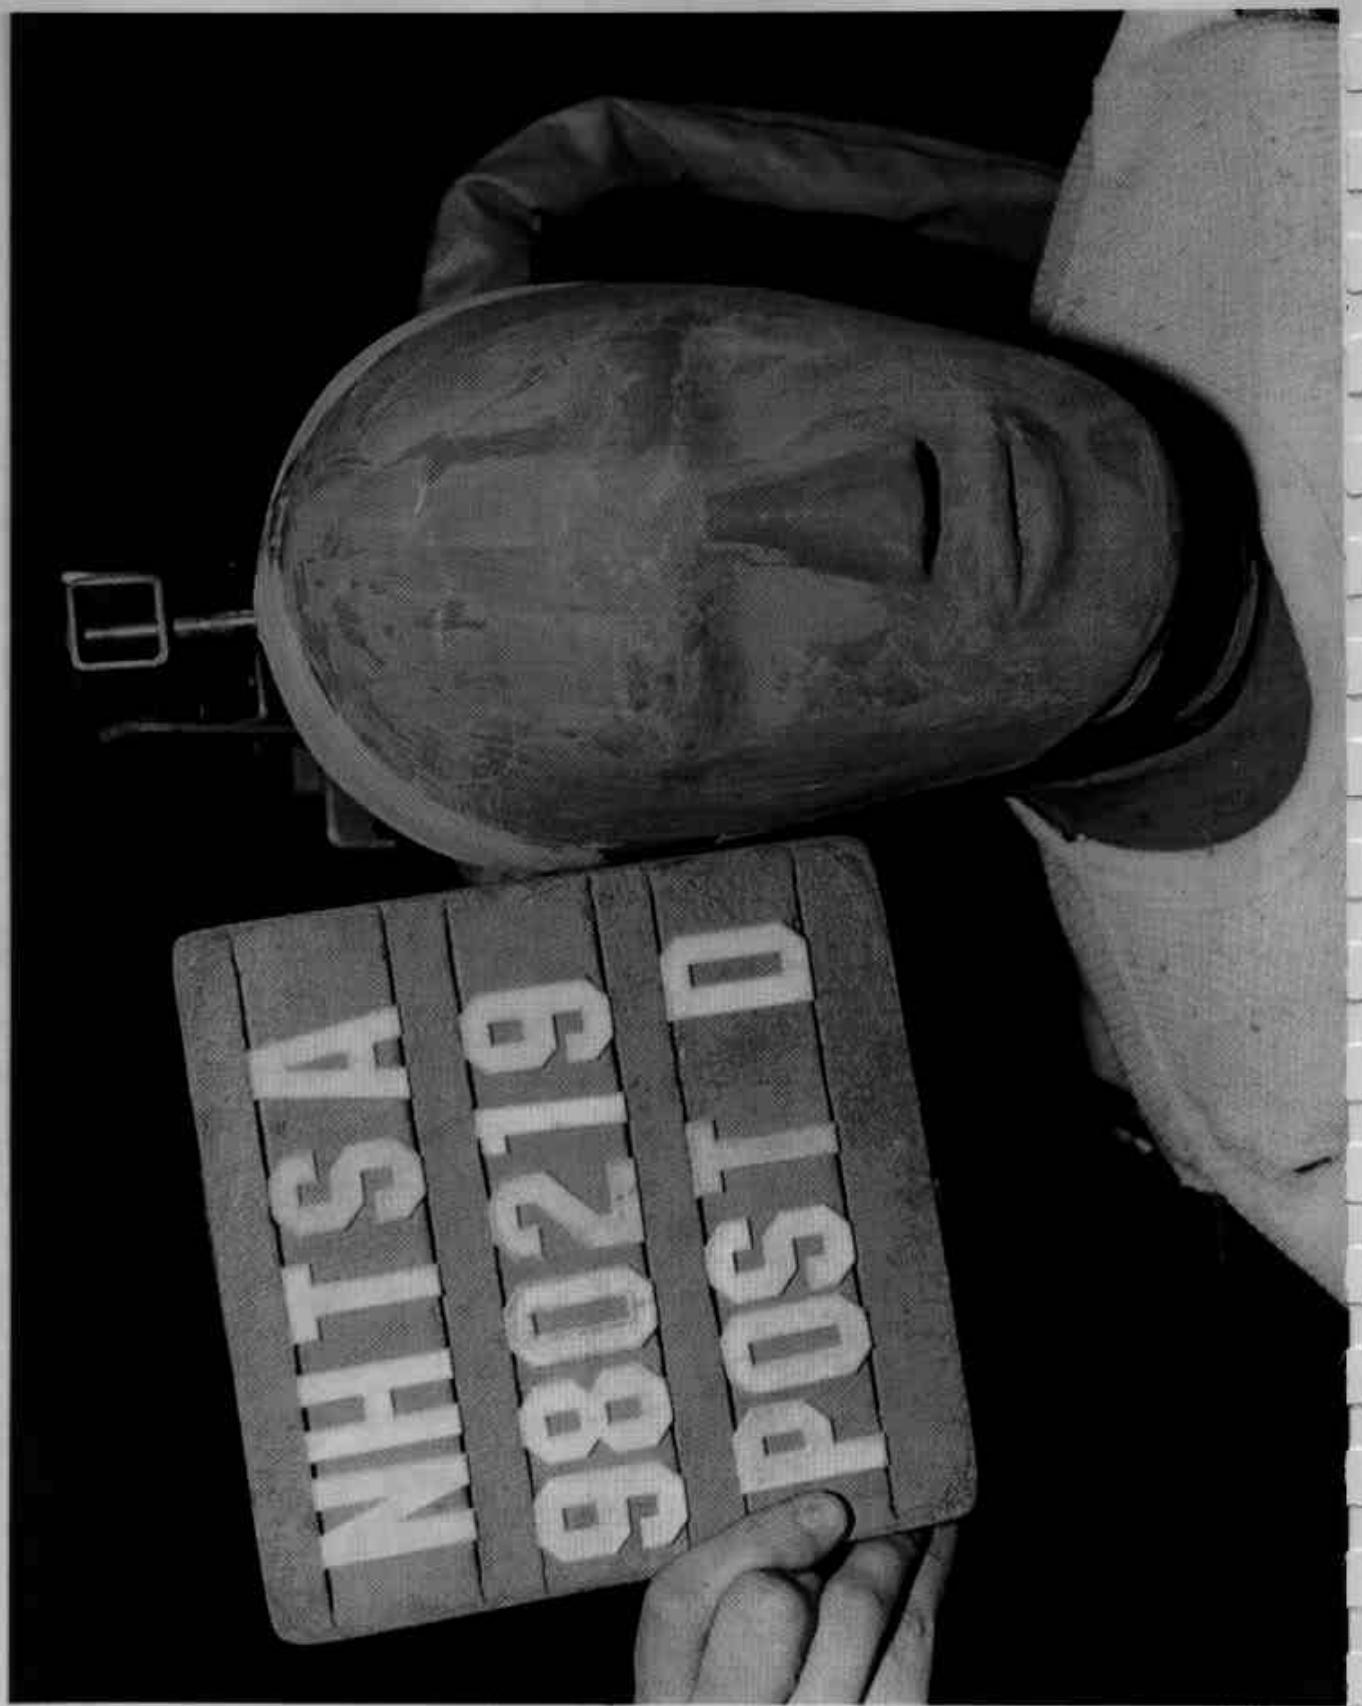
Figure A-40 Post-Test Driver Dummy Head Contact - View I

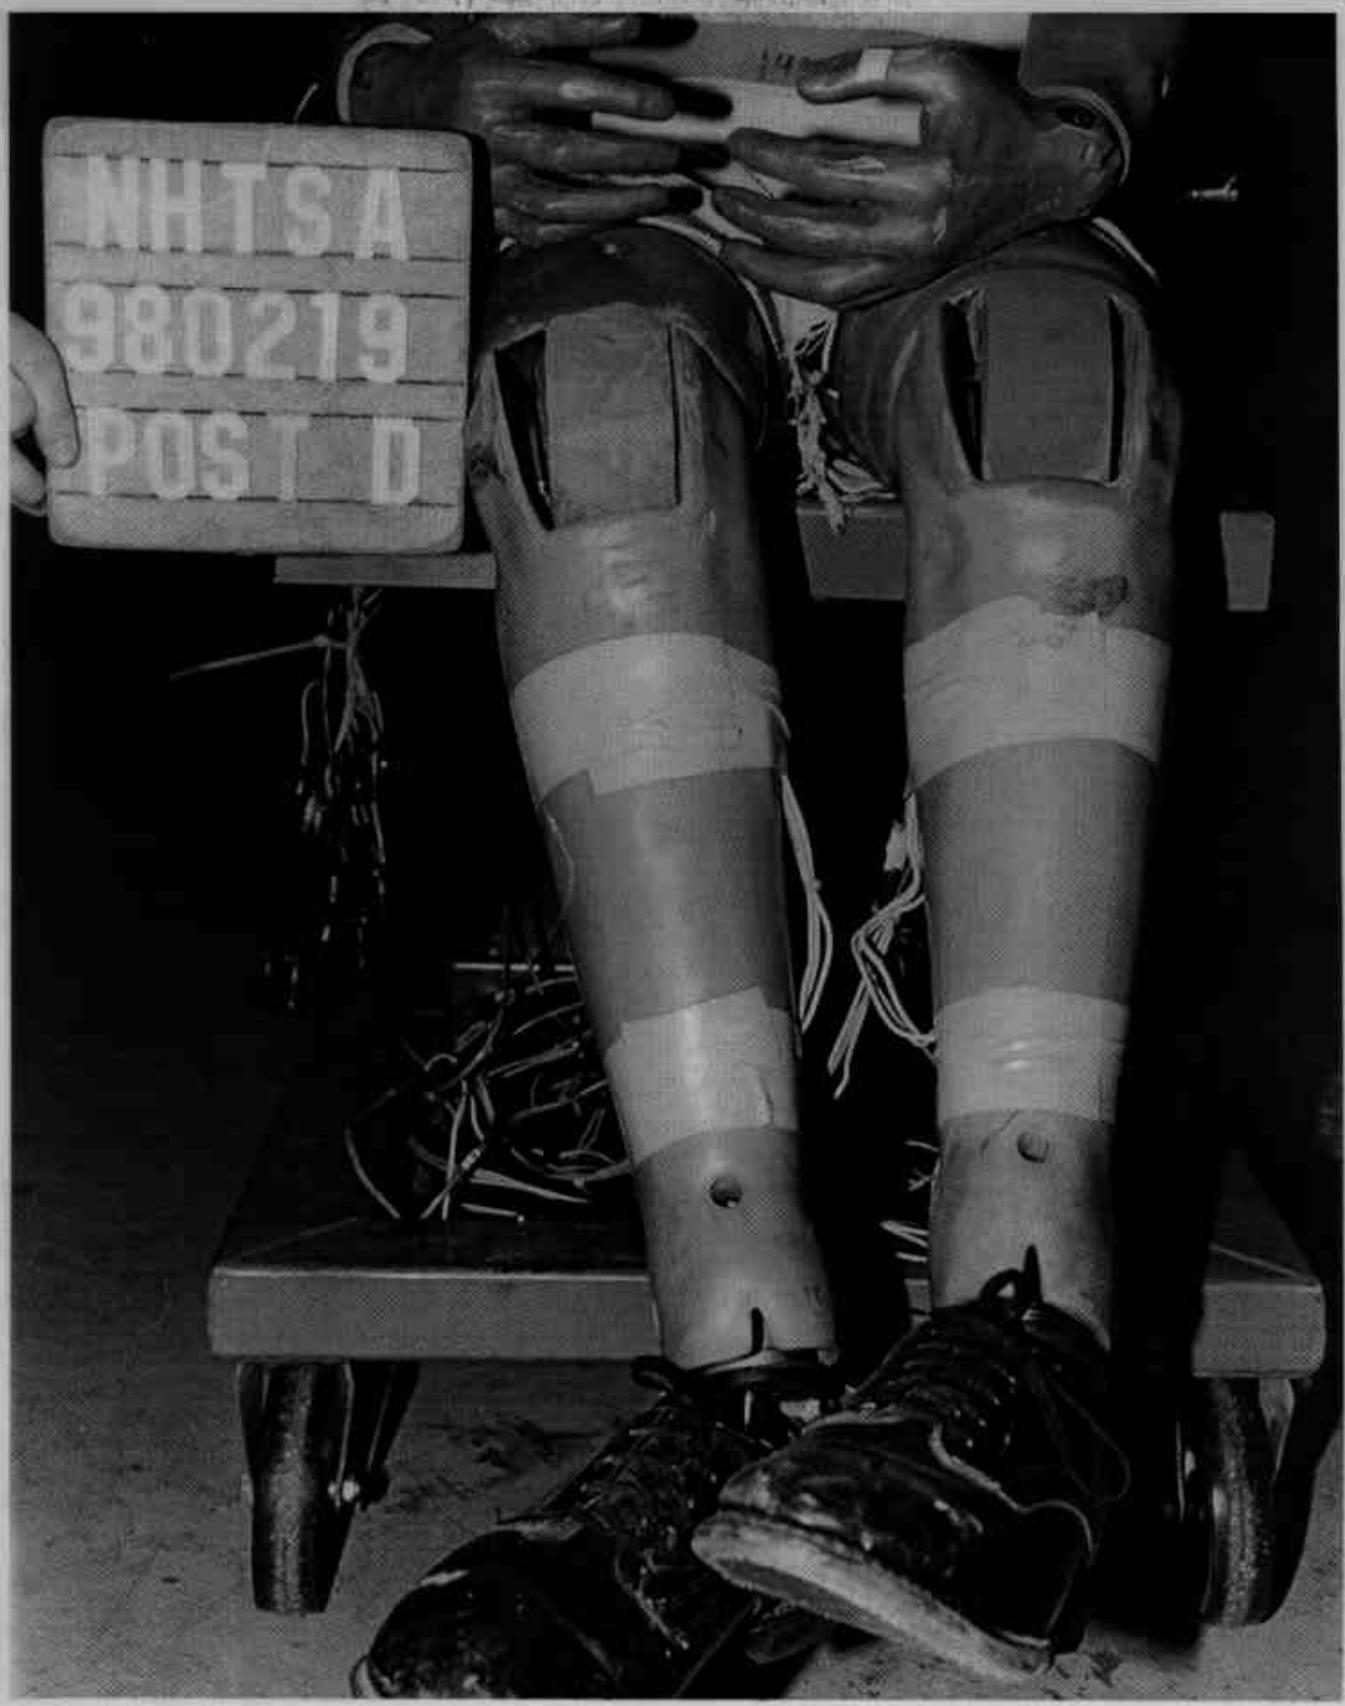
Figure A-43 Post-Test Driver Dummy Knee Contact - View 1

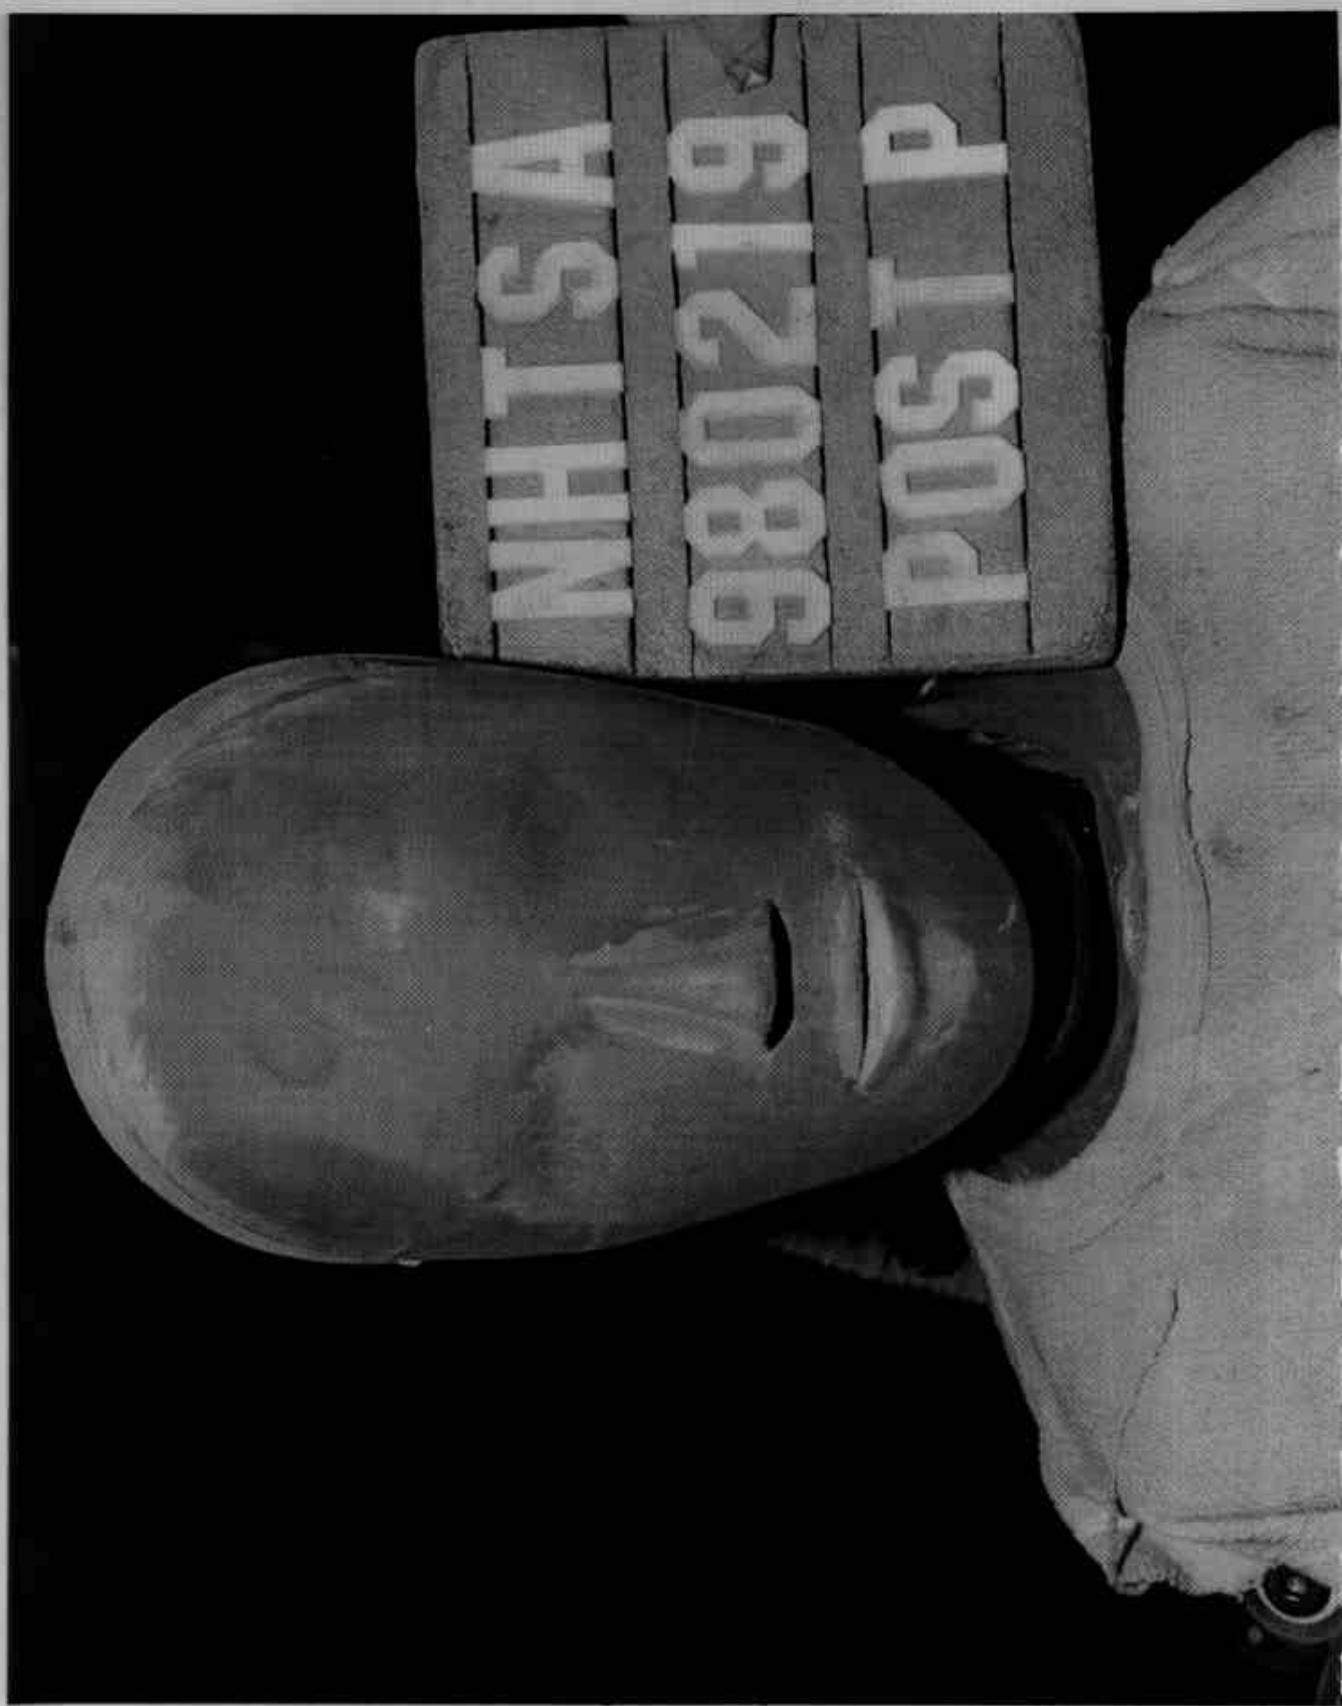
Figure A-46 Post-Test Passenger Dummy Head Contact - View 1

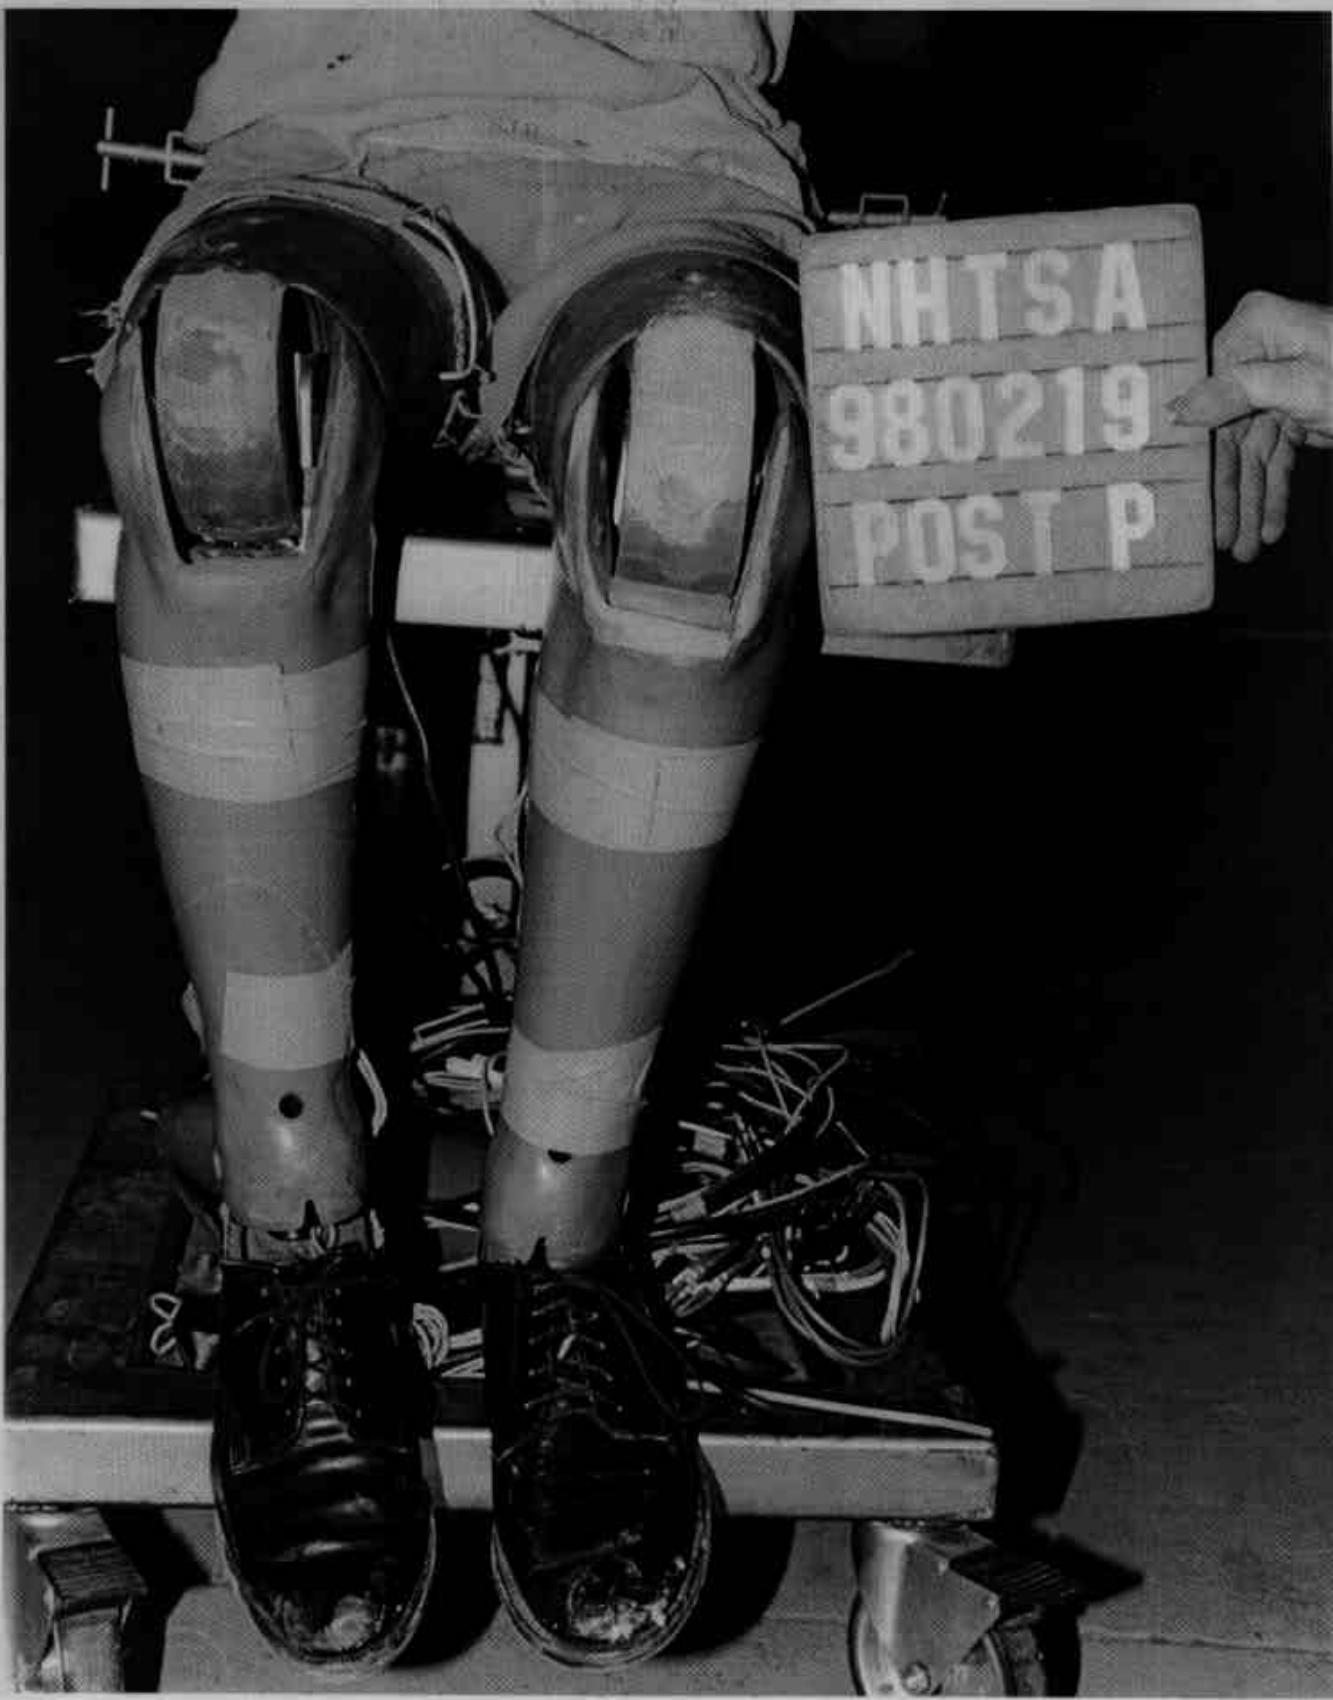
Figure A-49 Post-Test Passenger Dummy Knee Contact - View 1

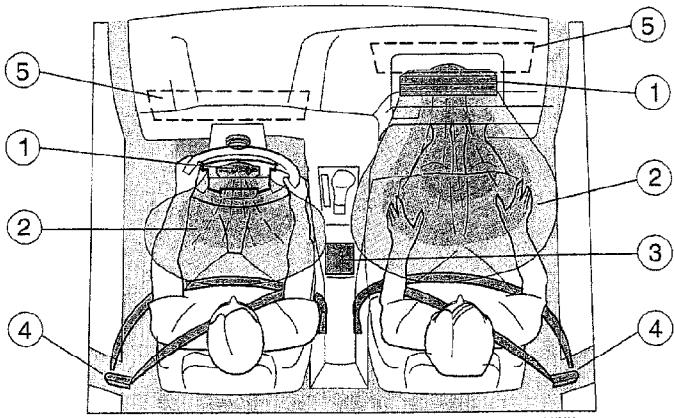
<sup>1</sup> With respect to tow track centerline.

The airbag system includes gas generators (1) surrounded by the airbags (2) and front seat belt tensioners for both of the front seats (4). To deploy the system, the sensor (3) activates the gas generators causing the airbags to be inflated with nitrogen gas. As the movement of the seats' occupants compresses the airbags, some of the gas is expelled at a controlled rate to provide better cushioning. Both seat belt tensioners also deploy, minimizing any seat belt slack.

The entire process, including inflation and deflation of the airbags, takes approximately two-tenths of a second.
